## TEST REPORT

<b>Laboratory</b>	ROOF AND FAÇADE ELEMENTS (CAR)	<b>O/References</b>	DE 651XL019 CAR 13222/1BIS (85) Page 1/9
-------------------	--------------------------------	---------------------	---

<b>Requested by</b>	<b>OFITECH</b> Zone Industrielle BP.17 F - 76 480 YAINVILLE Tel. : 0033 235 05 90 74 Fax : 0033 235 05 90 70		
<b>Date of the order</b>	2013.09.18	<b>Samples registration</b>	2013 – 50 – 035/1
		<b>Date of receipt of samples</b>	2013.11.19
<b>Date of the test</b>	2013.11.28 & 29		
<b>Drafting date of the report</b>	2015.04.28 (cancels and replaces test report CAR 13222 of 2013.12.12)		
<b>Test carried out</b>	Wind uplift test on roof element (metal + « ONDUVILLA » + screw « SPEEDY SCREW »)		
<b>References</b>	ETAG 006 – "Technical guidelines for approval of waterproof systems of mechanically fixed roofs" – Version 2000

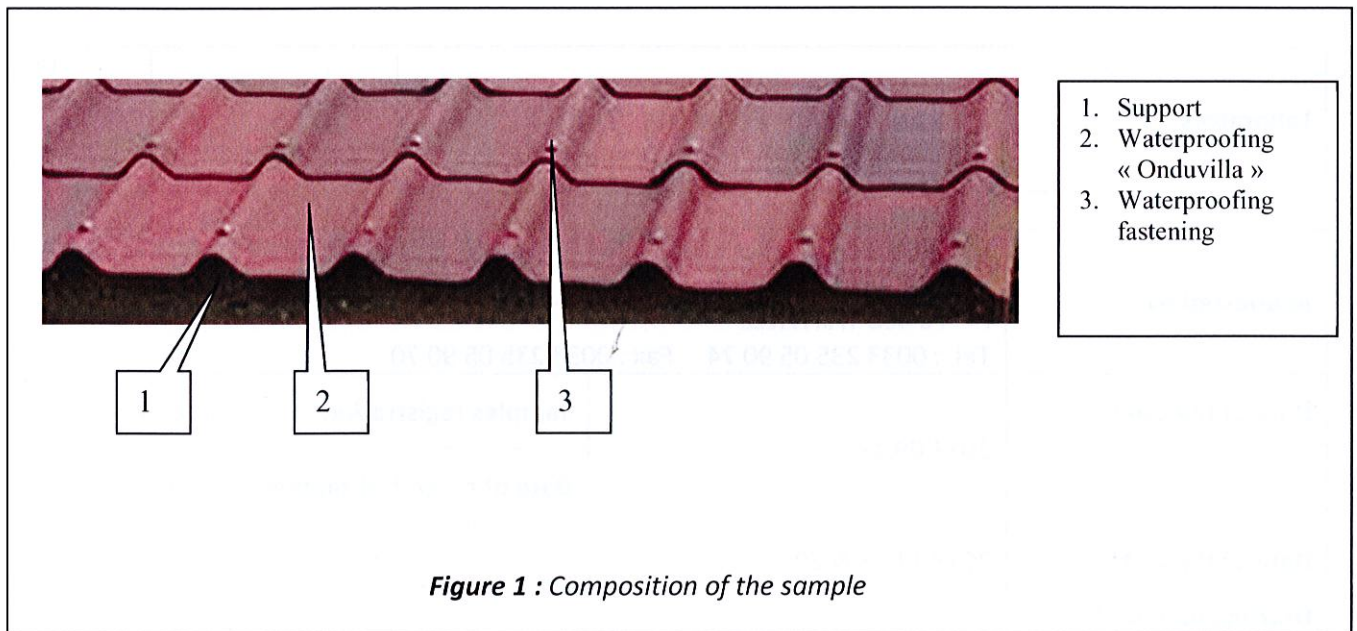
The composition of the sample is given in figure 1. The sample is laid under the test box (see figure 3)

- Dimensions of the sample : 2000 × 2000 mm
- Dimensions of the test box : 2000 × 2000 mm

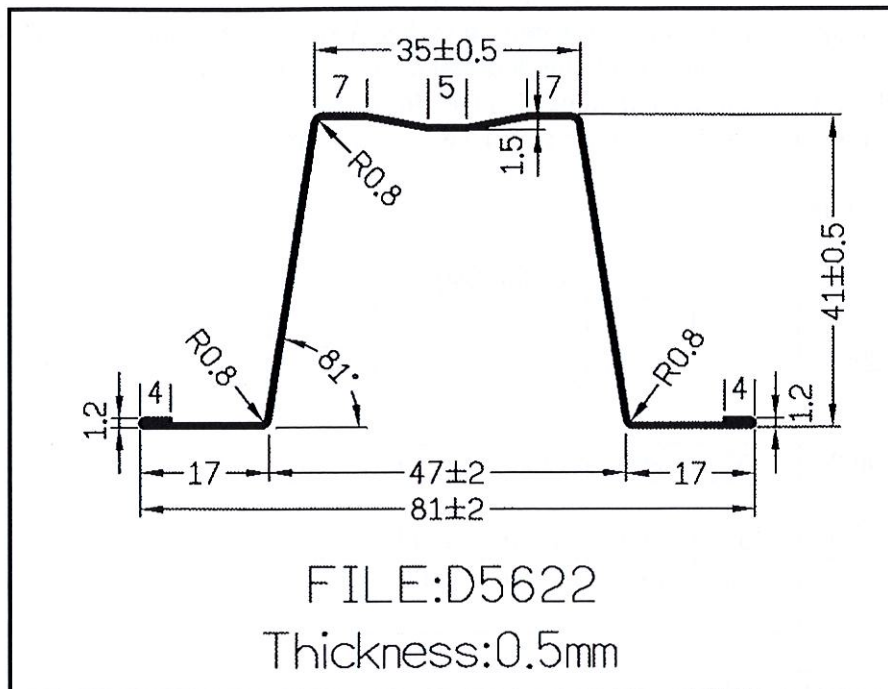
**Figure 2** : Dimensions of the used metal profiles

<b>1</b>	<b>Support</b>	Metal profiles; form and dimensions see figure 2 ; distance between two profiles: 320 mm
<b>2</b>	<b>Waterproofing</b>	Corrugated bitumen tiles « ONDUVILLA PPHR » ; thickness : 2,9 mm ; lateral overlapping: 1 corrugation + technical datasheet figure 6.
<b>3</b>	<b>Waterproofing fixing</b>	Screw « ONDULINE UNIVERSAL SPEEDY SCREW » Ø 3,9 × 60 mm ; one screw per corrugation + technical datasheet figure 7.

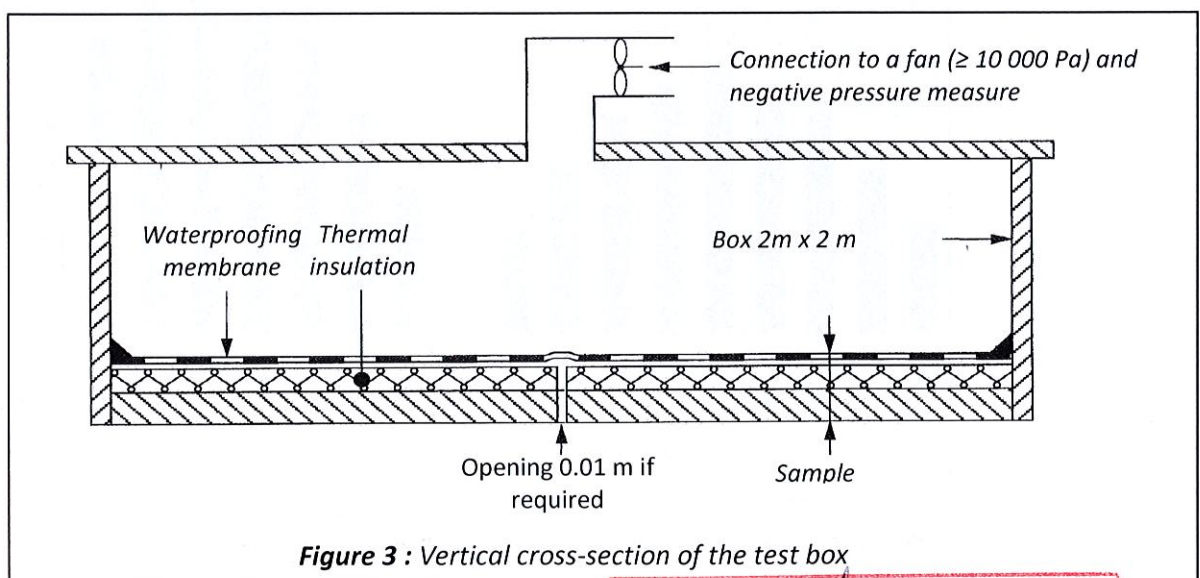
**Figure 3** : Vertical cross-section of the test box

The windresistance of a roof system is determined based on a pressure chamber test in accordance with the guidelines ETAG 006 – “Technical guidelines for approval of waterproof systems of mechanically fixed roofs” – Version 2000 (see figure 3).

The negative pressure cycles are applied under the test box with a fan and an electronically controlled valve system allowing the creation of cycles. A storm is a sequential combination of negative pressure cycles. One applies the depressions indicated in figure 4. The test continues until the breaking of the sample per steps of 500 Pa for  $Q_{100\%}$ .

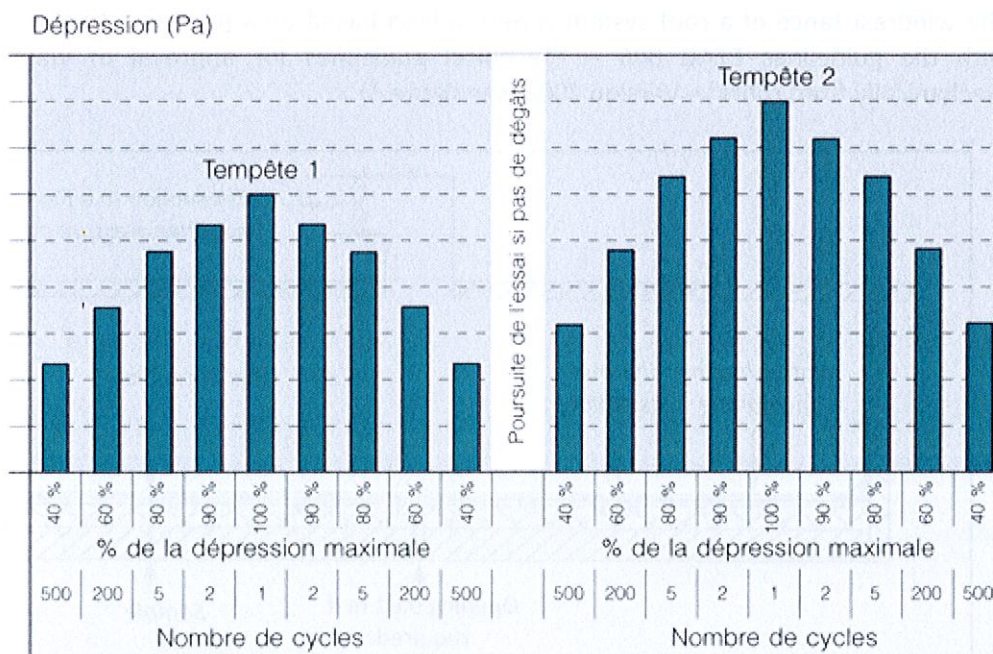
**Figure 4** : Sequential combination of negative pressure cycles during a storm

The maximum negative pressure of each storm, i.e.  $Q_{100\%}$ , is defined for illustration in table 1.

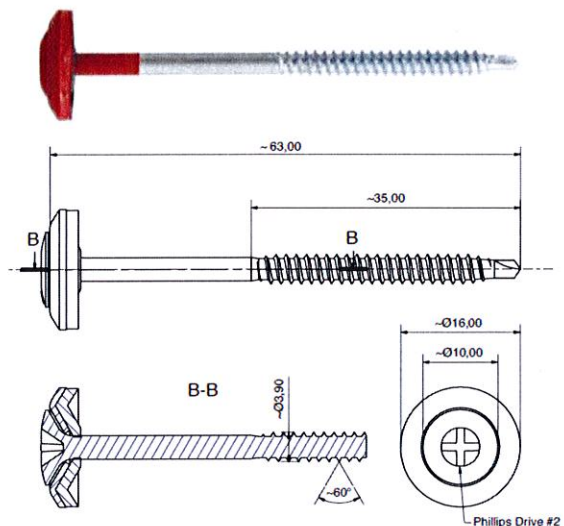
**Figure 7 : Technical datasheet of screws « ONDULINE UNIVERSAL SPEEDY SCREW » 1**

Nominal diameter:	Ø3.9 mm
Length(L):	60 (+3) mm
Head:	LP™ (low profile) head with Phillips drive
Material:	Carbon steel (C1016 - C1022)
Drill point:	#15
Drill capacity:	Max. 2.0 mm (steel 280GD)
Washer:	Ø16mm M-washer in aluminium vulcanized EPDM rubber
Surface treatment:	Electroplated, 7 µm zink with blue chrome passivation
Service class:	2 (acc. EN 1995-1-1)
Corrosion category:	C2 (acc. EN ISO 12944-6)

The carrying capacity is calculated in accordance to the current standards. The tensile capacity for the connection are the minimum values of the pullout values and the tensile resistance of the screw. The head pull-through resistances is not taken into account.
